**RCRA FACILITY INVESTIGATION**  
**DU PONT EXPERIMENTAL STATION**  
**DRAFT FINAL REPORT**

**RCRA FACILITY INVESTIGATION  
DuPont EXPERIMENTAL STATION  
DRAFT FINAL REPORT**

**GeoTrans, Inc.  
46050 Manekin Plaza  
Suite 100  
Sterling, Virginia 22170**

**GeoTrans Project No. 8788-000**

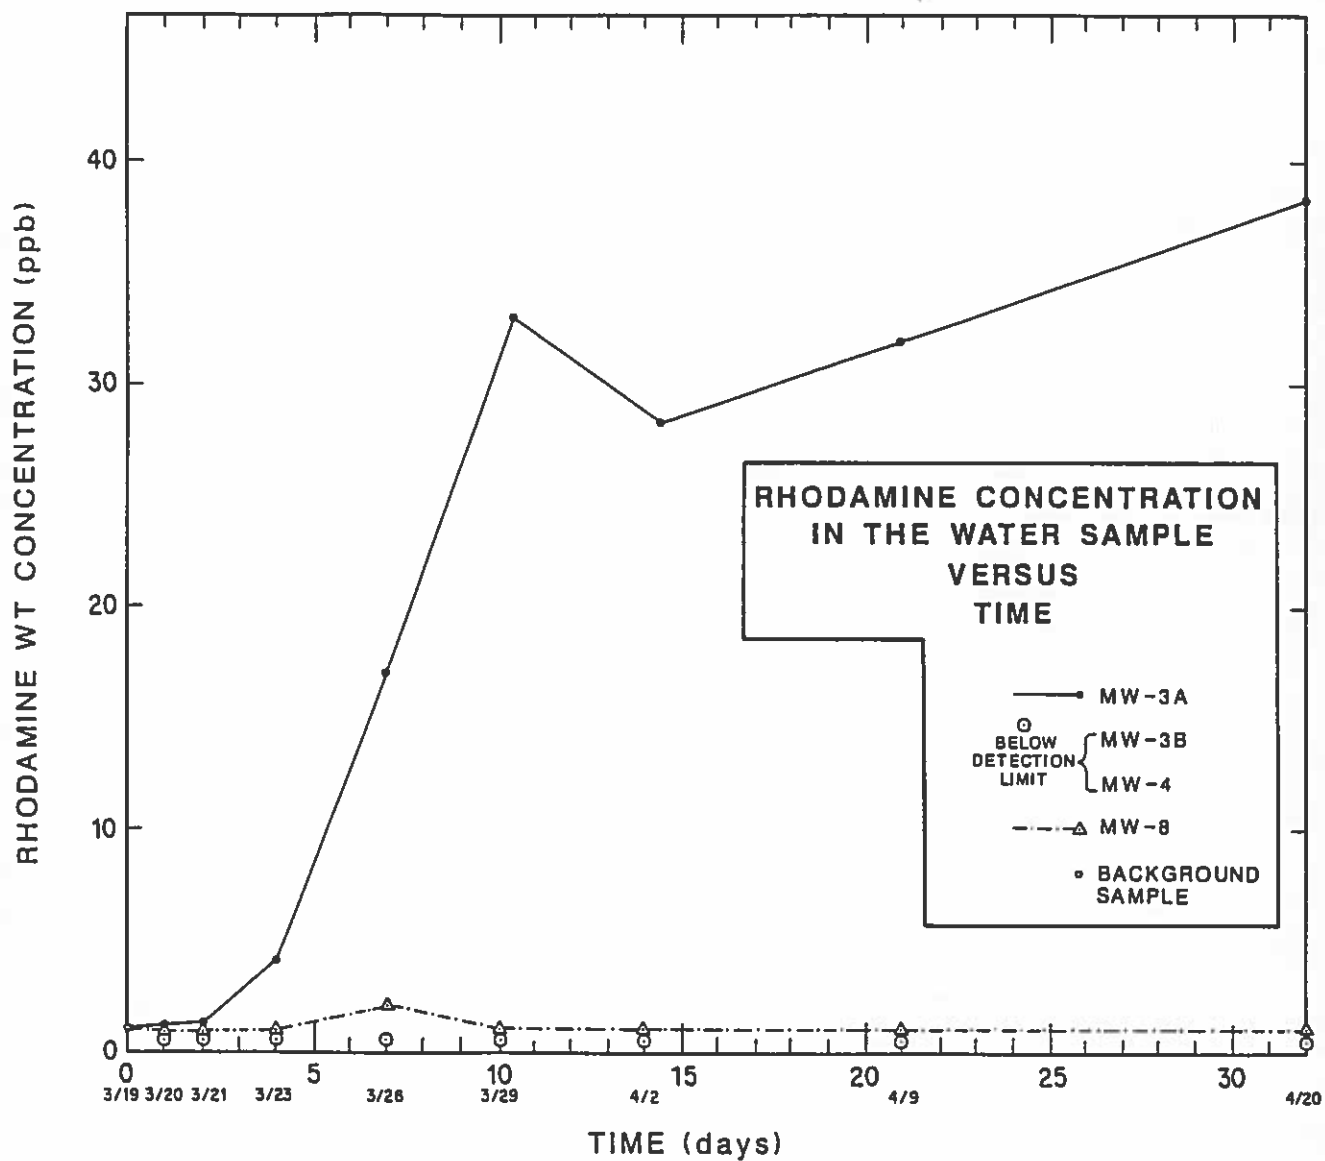
Figure 4.25. Tracer study results for water samples from wells.

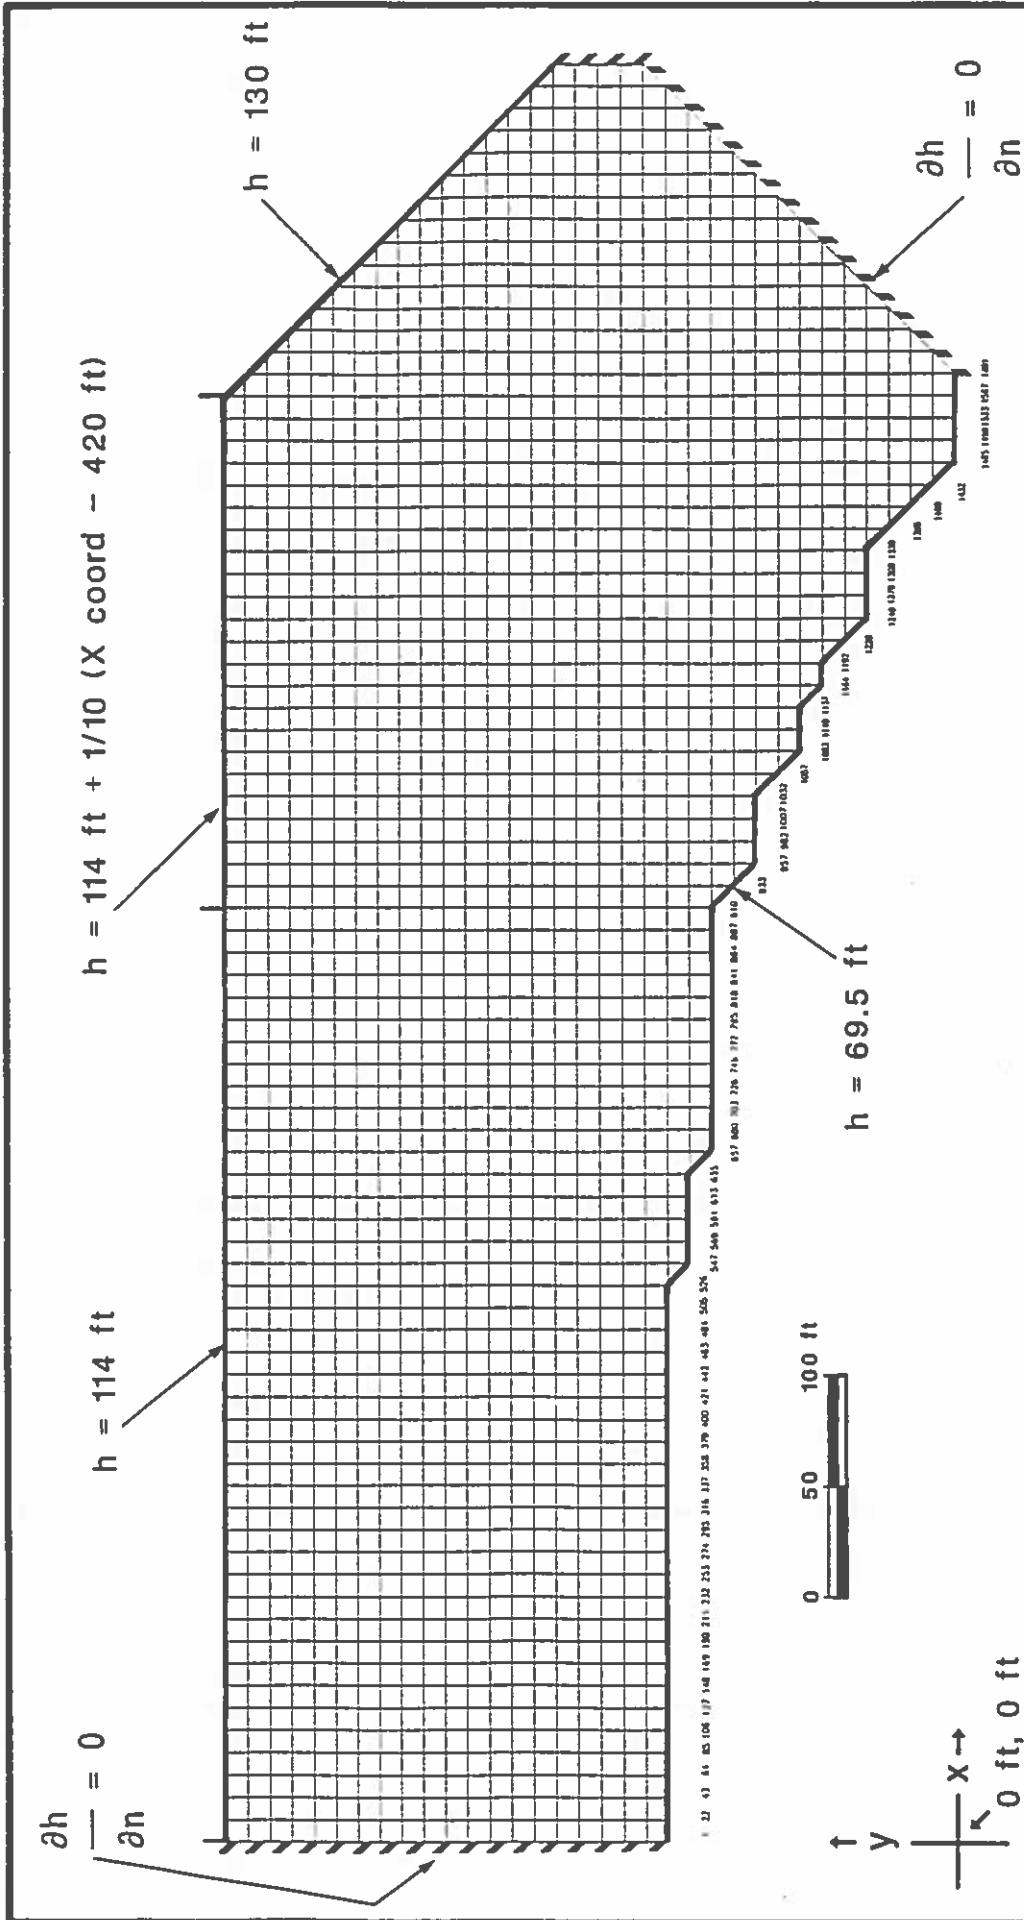
Figure 5.3. Finite-element grid showing boundary conditions used in flow simulations.

Recharge in the study area is small compared to the flow from upgradient because of the steep slopes and pavement and buildings. Thus, the boundary conditions and transmissivity controlled the simulated flow field.

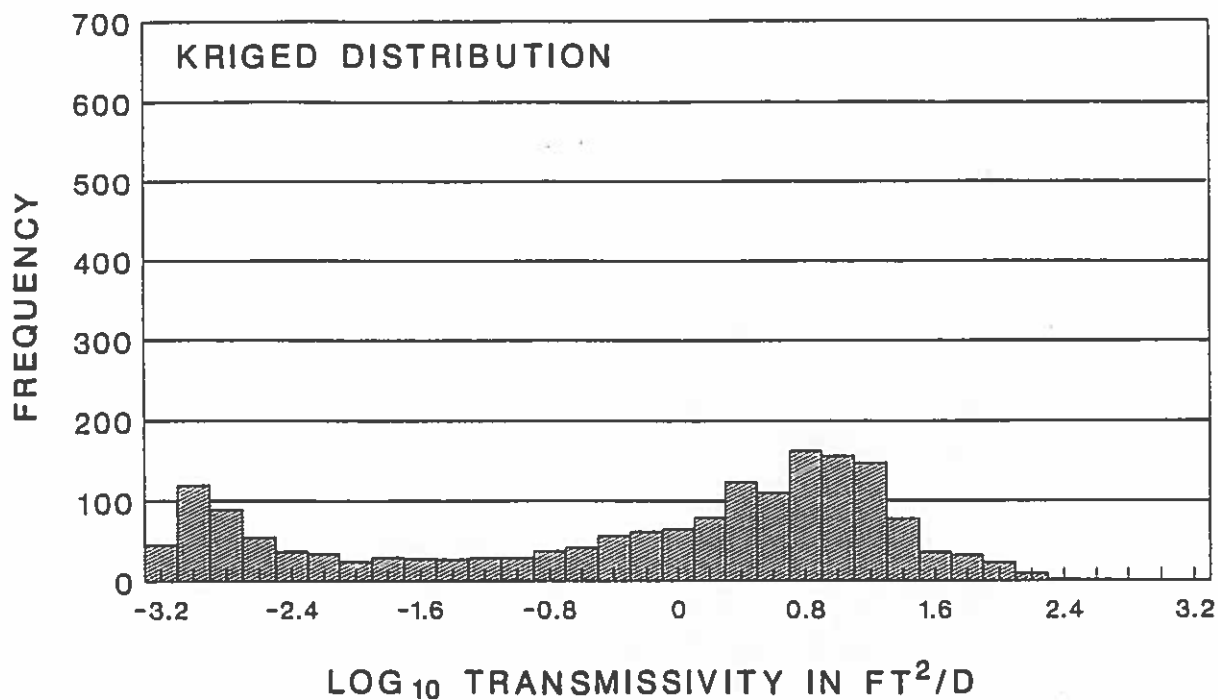
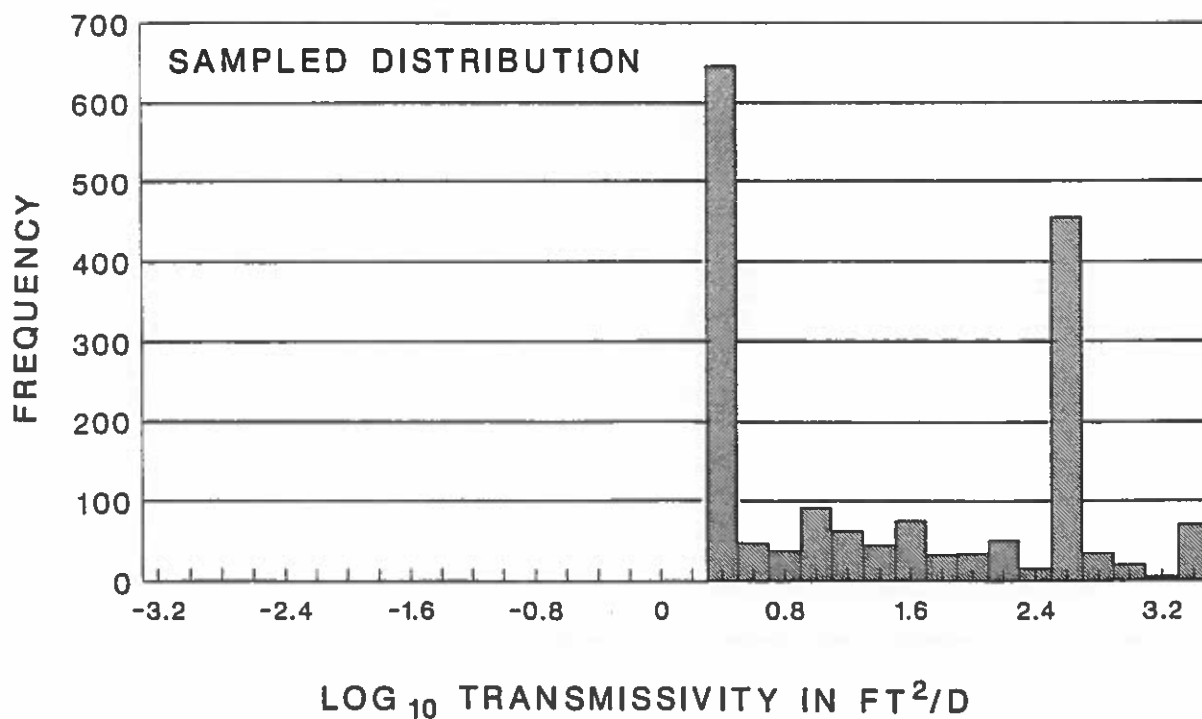
Figure 5.4. Distribution of transmissivity values for all elements in the numerical grid: above: mean values computed from kriging program; below: values based on statistical sampling procedure with lower bound of 2.4 ft<sup>2</sup>/day for transmissivity.
